Manhole Inspection Summary

Manhole # S71S__012MH

Insp Date: **4/10/08 10:51 AM**

Location Address: **6713 Roberts Ave.**

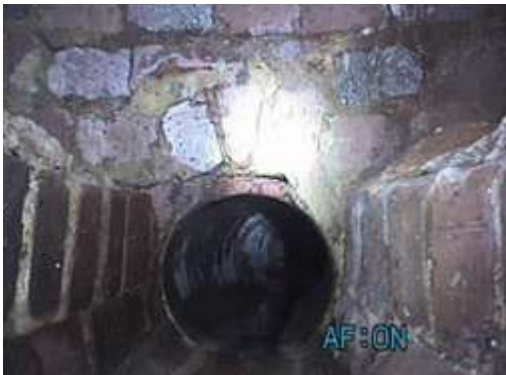
Defect 4

Broken Seal 12'Oclock

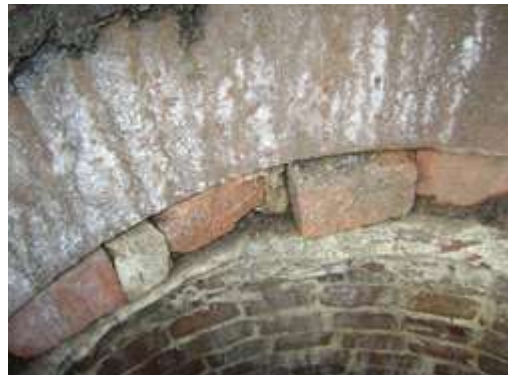
Defect 1

Condition: ☐ Sound ☐ Cracked ☐ Root Intrusion ☒ Loose Brick ☒ Deteriorated

Loose Bricks-chimney under frame

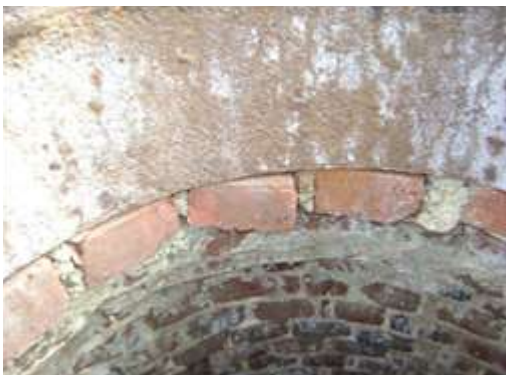
Defect 2

Deterioration-chimney under frame

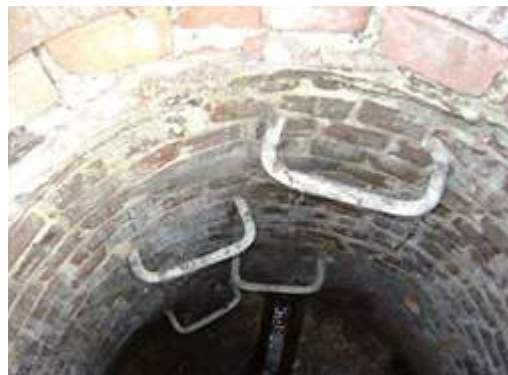
Defect 3

Slight infiltration through mortar of chimney, corbel, and barrel.

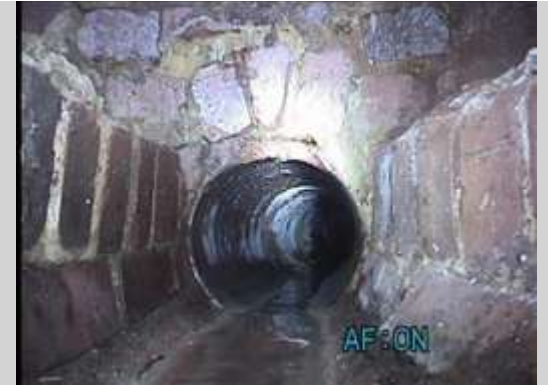
12 O'Clock Outflow

Pipe Height: **8.4** (in.) Rod and Bar (Angled)
Pipe Material: **Clay** ☐ Pipe Lined
Invert Depth: **7.54** (ft.) Flow Characteristics: **Fast**
Deposits: ☒ None ☐ Mud ☐ Sludge ☐ Debris ☐ Grease
Silt Depth: (in.) Deposits Extent:
Infiltration: **None** Pipe Seal Cond: **Broken**
